Debris/Ice/TPS Assessment and Integrated Photographic Analysis of Shuttle Mission STS-78

*Gregory N. Katnik
Process Engineering/Mechanical System Division/ET-SRB Branch,
Kennedy Space Center, Florida*

**DEBRIS/ICE/TPS ASSESSMENT
AND
INTEGRATED PHOTOGRAPHIC ANALYSIS
OF
SHUTTLE MISSION STS-78**

20 June 1996

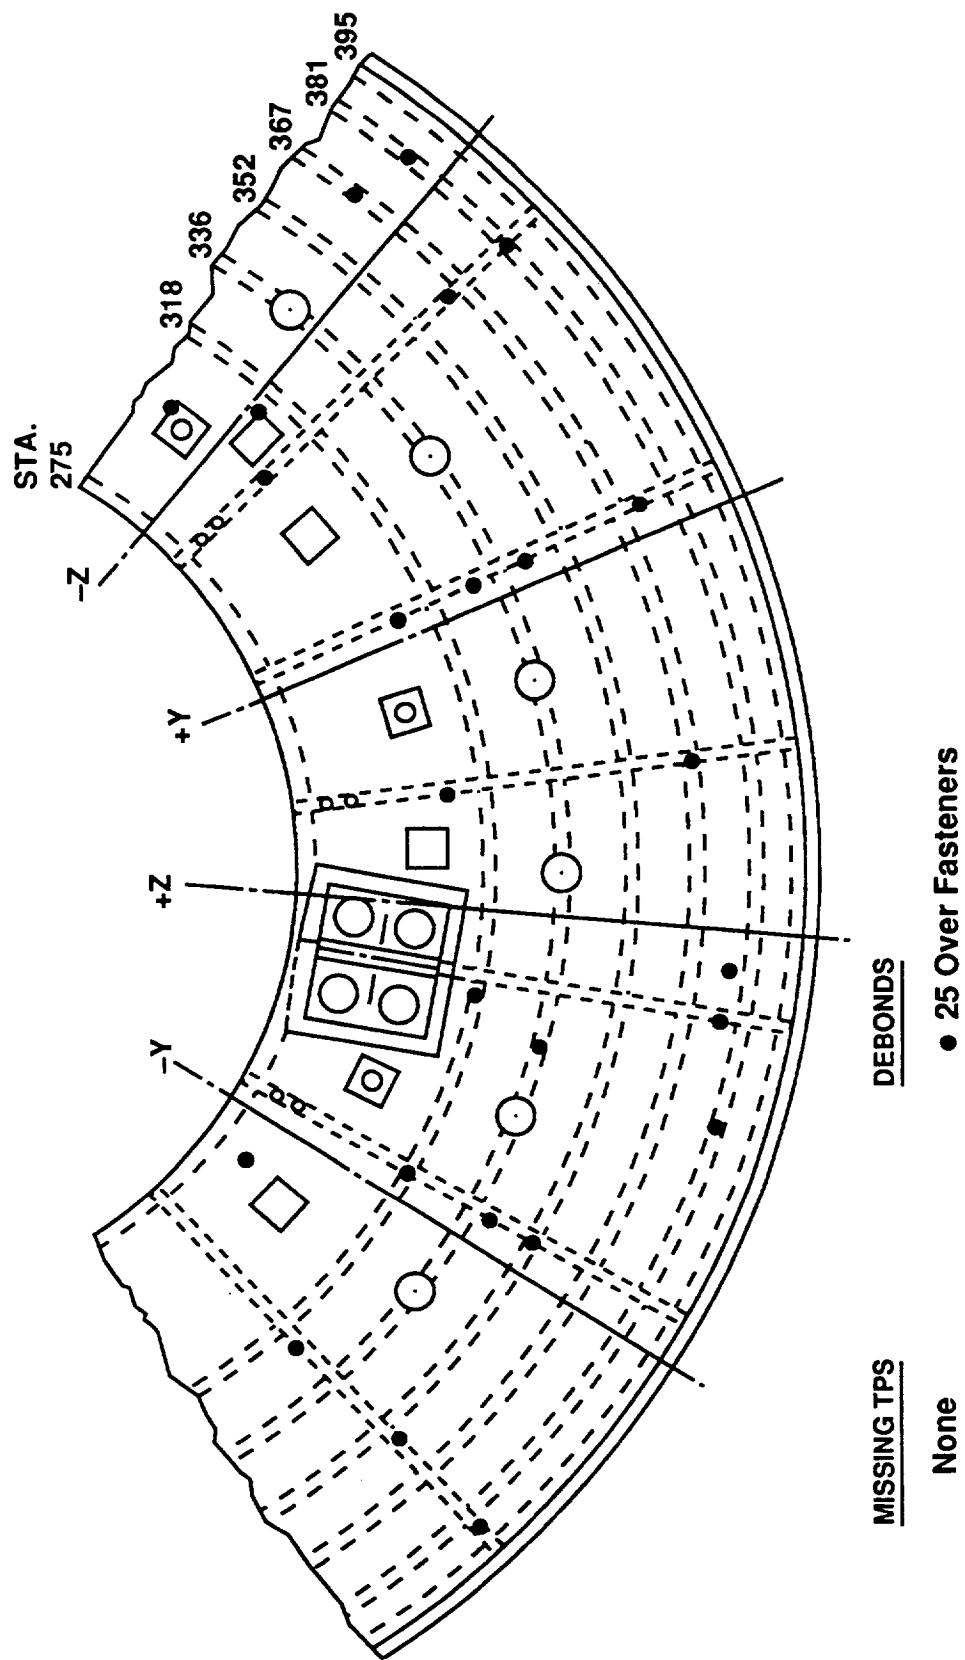
Figure 1: RH SRB Frustum

The RH frustum was missing no TPS. The number of debonds over fasteners (25) was less than average (Figure 1). Hypalon paint was blistered/missing along the XB-395 ring frame where BTA closeouts had been applied. However, most of the exposed BTA substrate was not sooted. The BSM aero heat shield covers had locked in the fully opened position.

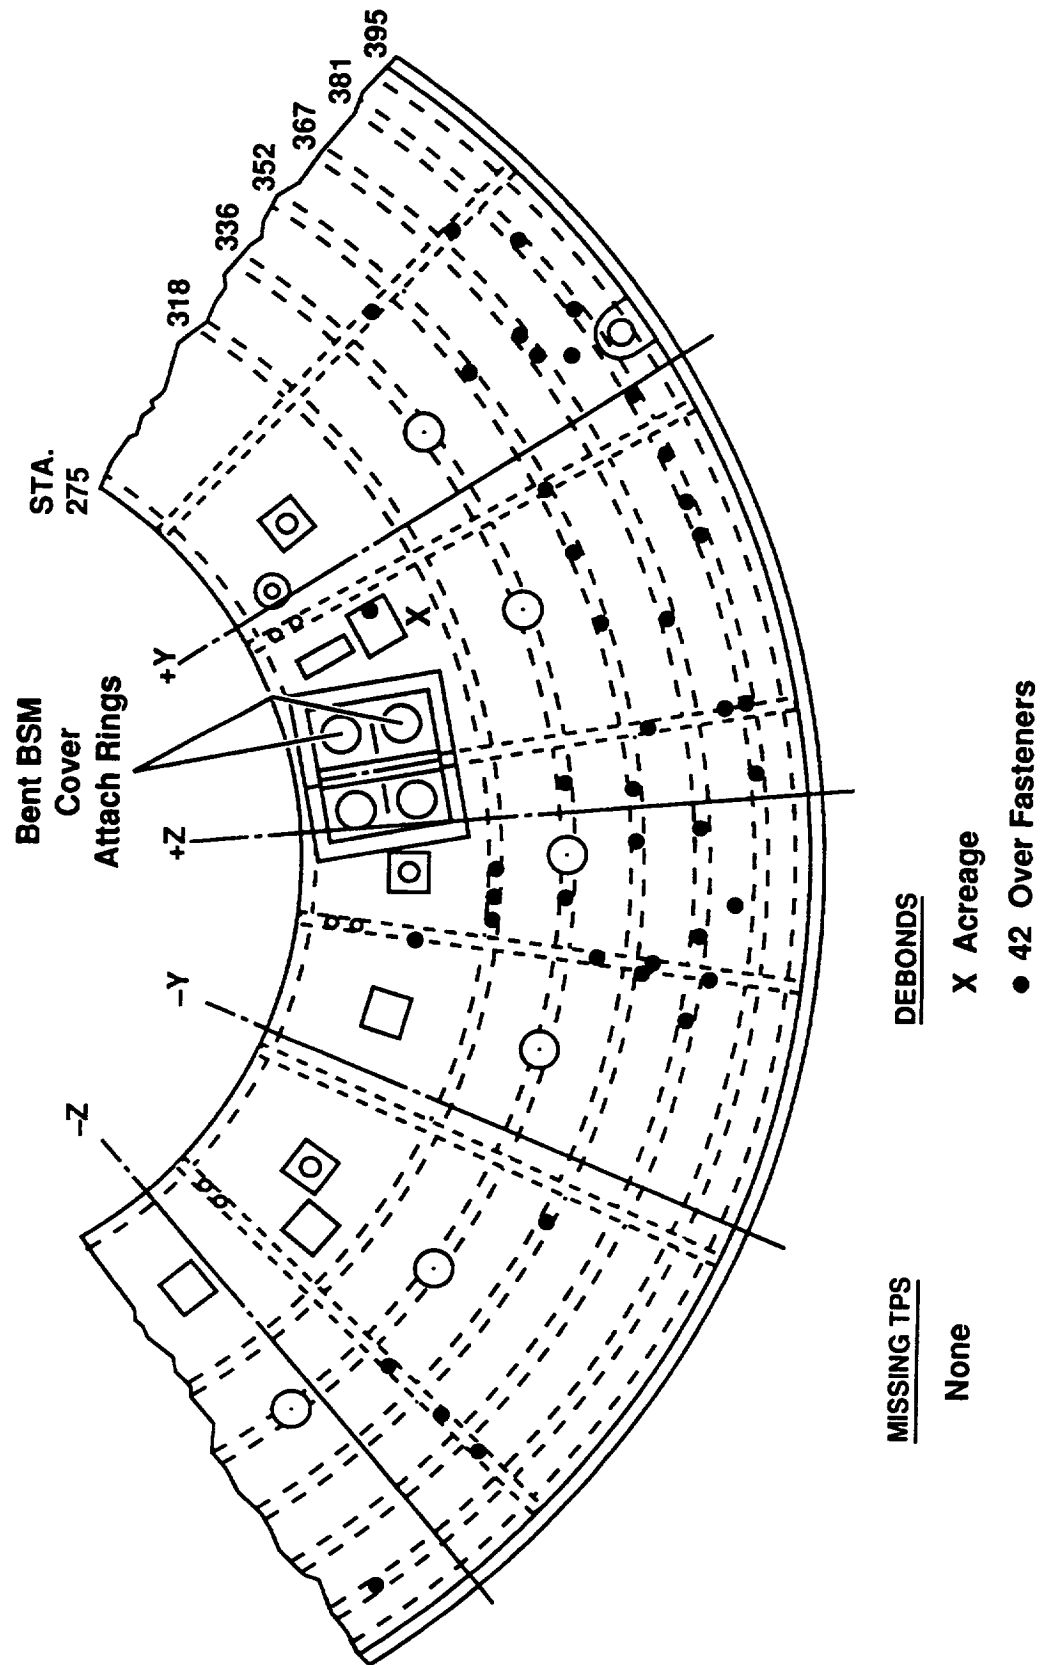
Figure 2: LH SRB Frustum

The LH frustum was missing no TPS. The number of MSA-2 debonds over fasteners (42) was somewhat greater than average with a large percentage of this number consisting of partial debonds on the leading edge of the fasteners (Figure 2). Hypalon paint was blistered/missing along the XB-395 ring frame where BTA closeouts had been applied. However, most of the exposed BTA substrate was not sooted. The BSM aero heat shield covers had locked in the fully opened position though the two right cover attach rings had been bent by parachute entanglement.

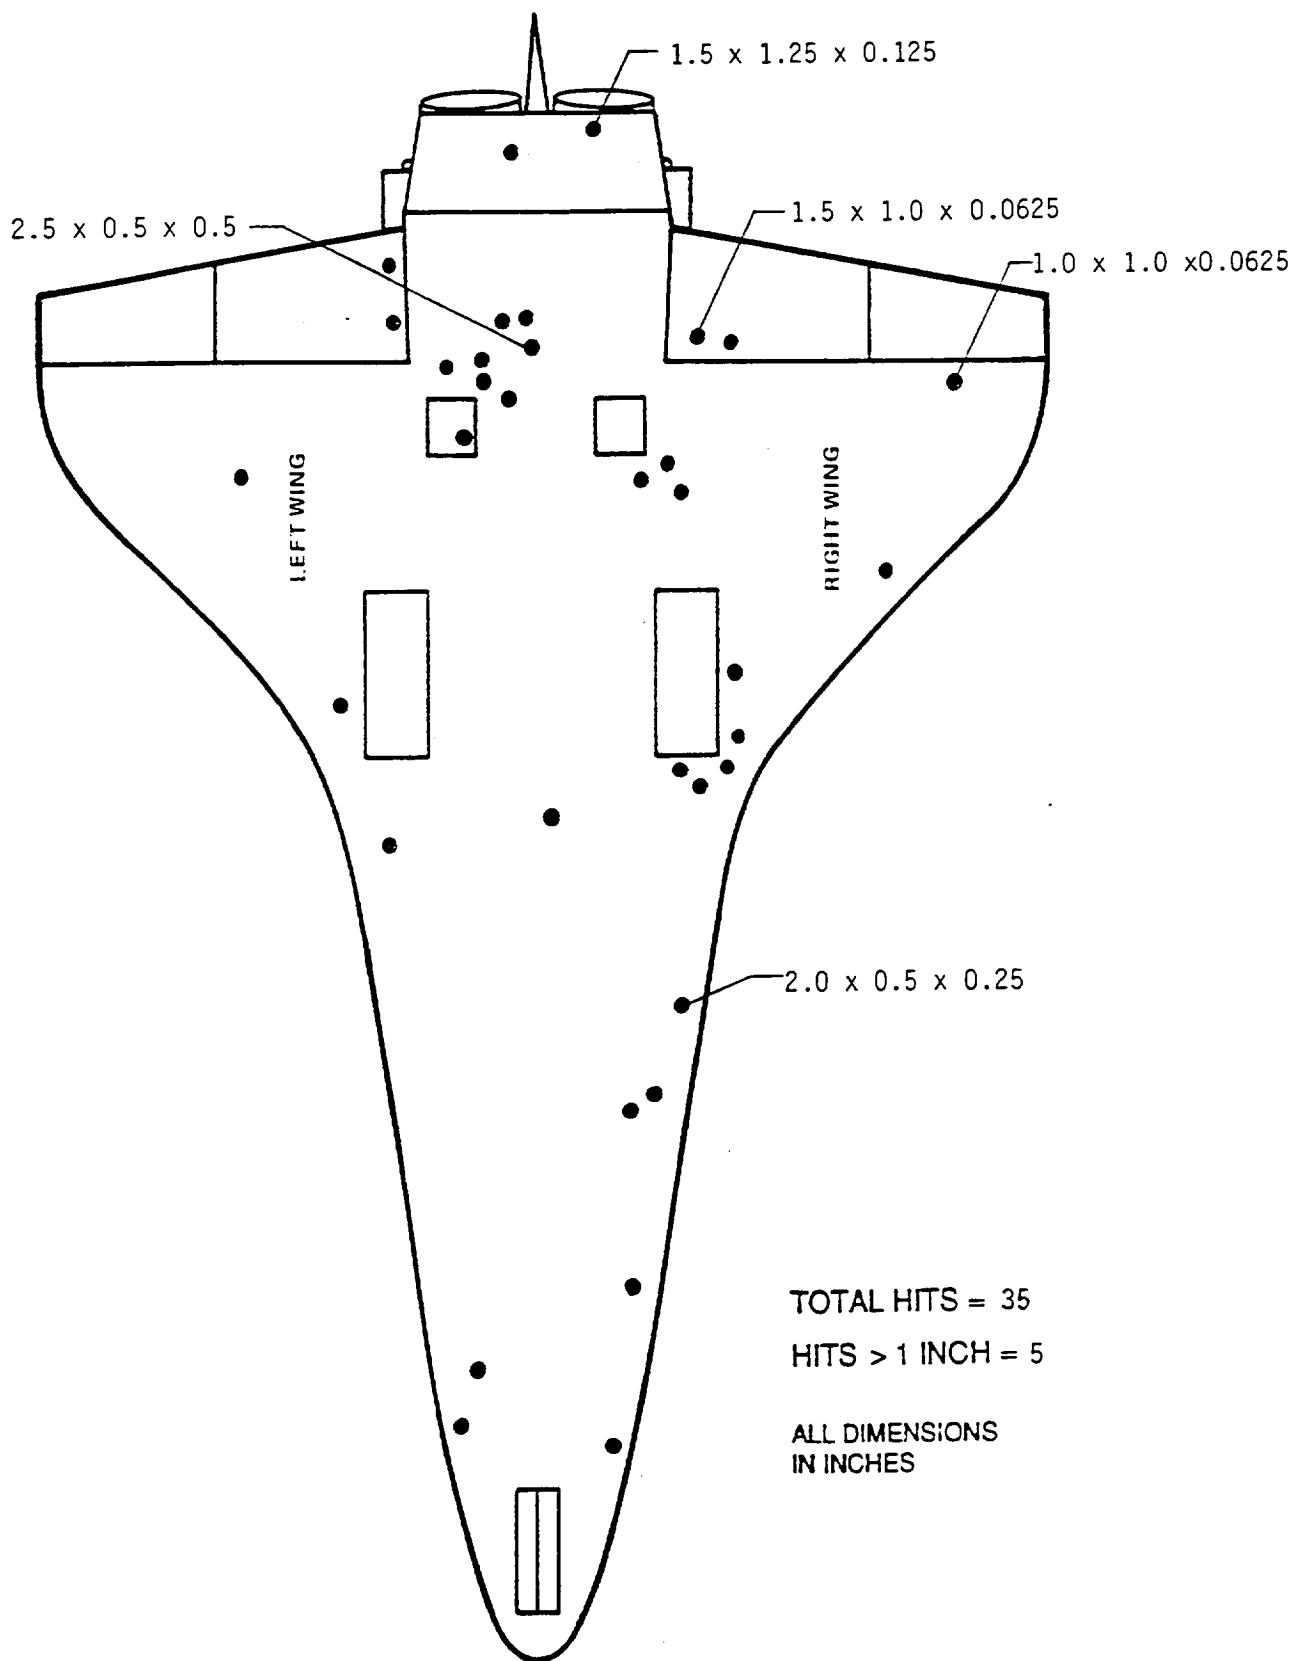
Figure 3: Orbiter Lower Surface Debris Map

The Orbiter lower surface sustained a total of 35 hits, of which 5 had a major dimension of 1-inch or larger. The largest lower surface tile damage site was located aft of the ET/ORB umbilicals and measured 2.5-inches long by 0.5-inches wide by 0.5-inch maximum depth. The damage was most likely caused by an ice impact from the umbilicals.

In summary, both the total number of Orbiter TPS debris hits and the number of hits 1-inch or larger were significantly less than average when compared to previous missions.

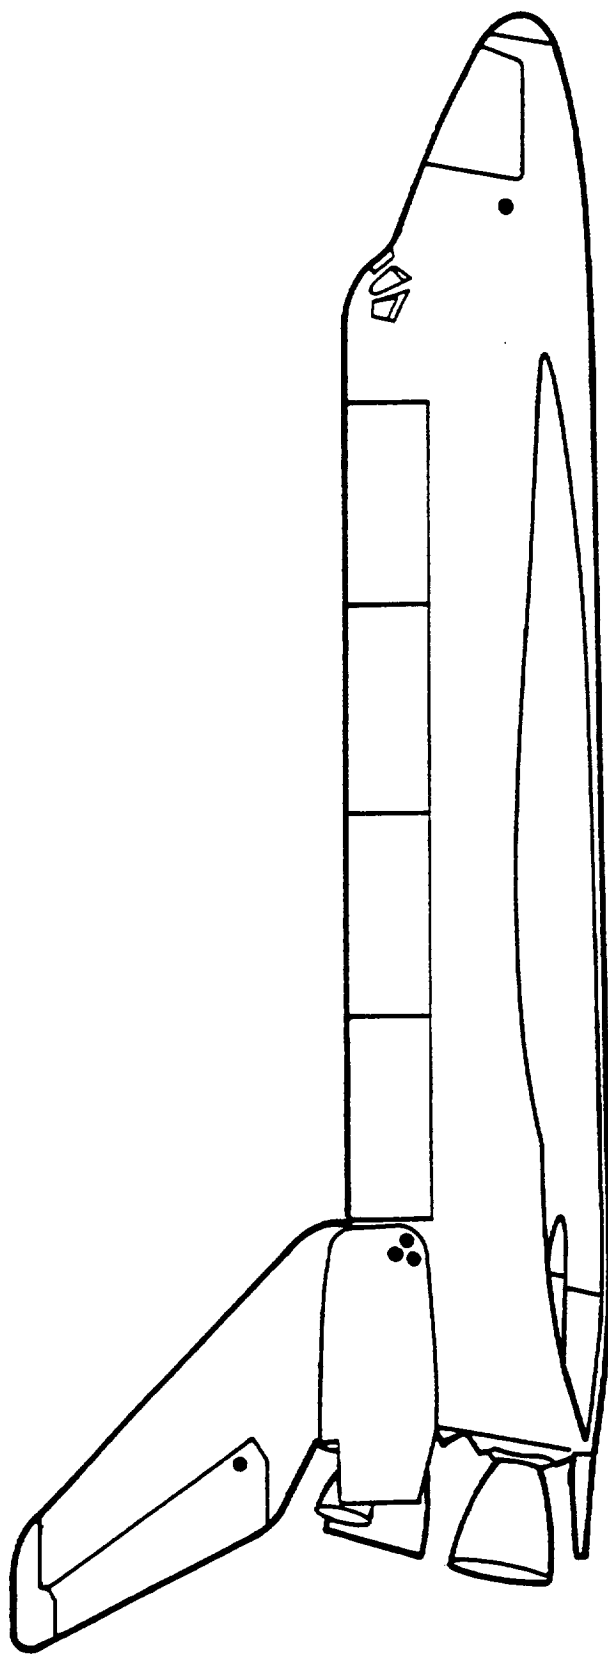
Figure 5: Orbiter Right Side Debris Map

TOTAL HITS = 5
HITS > 1 INCH = 0

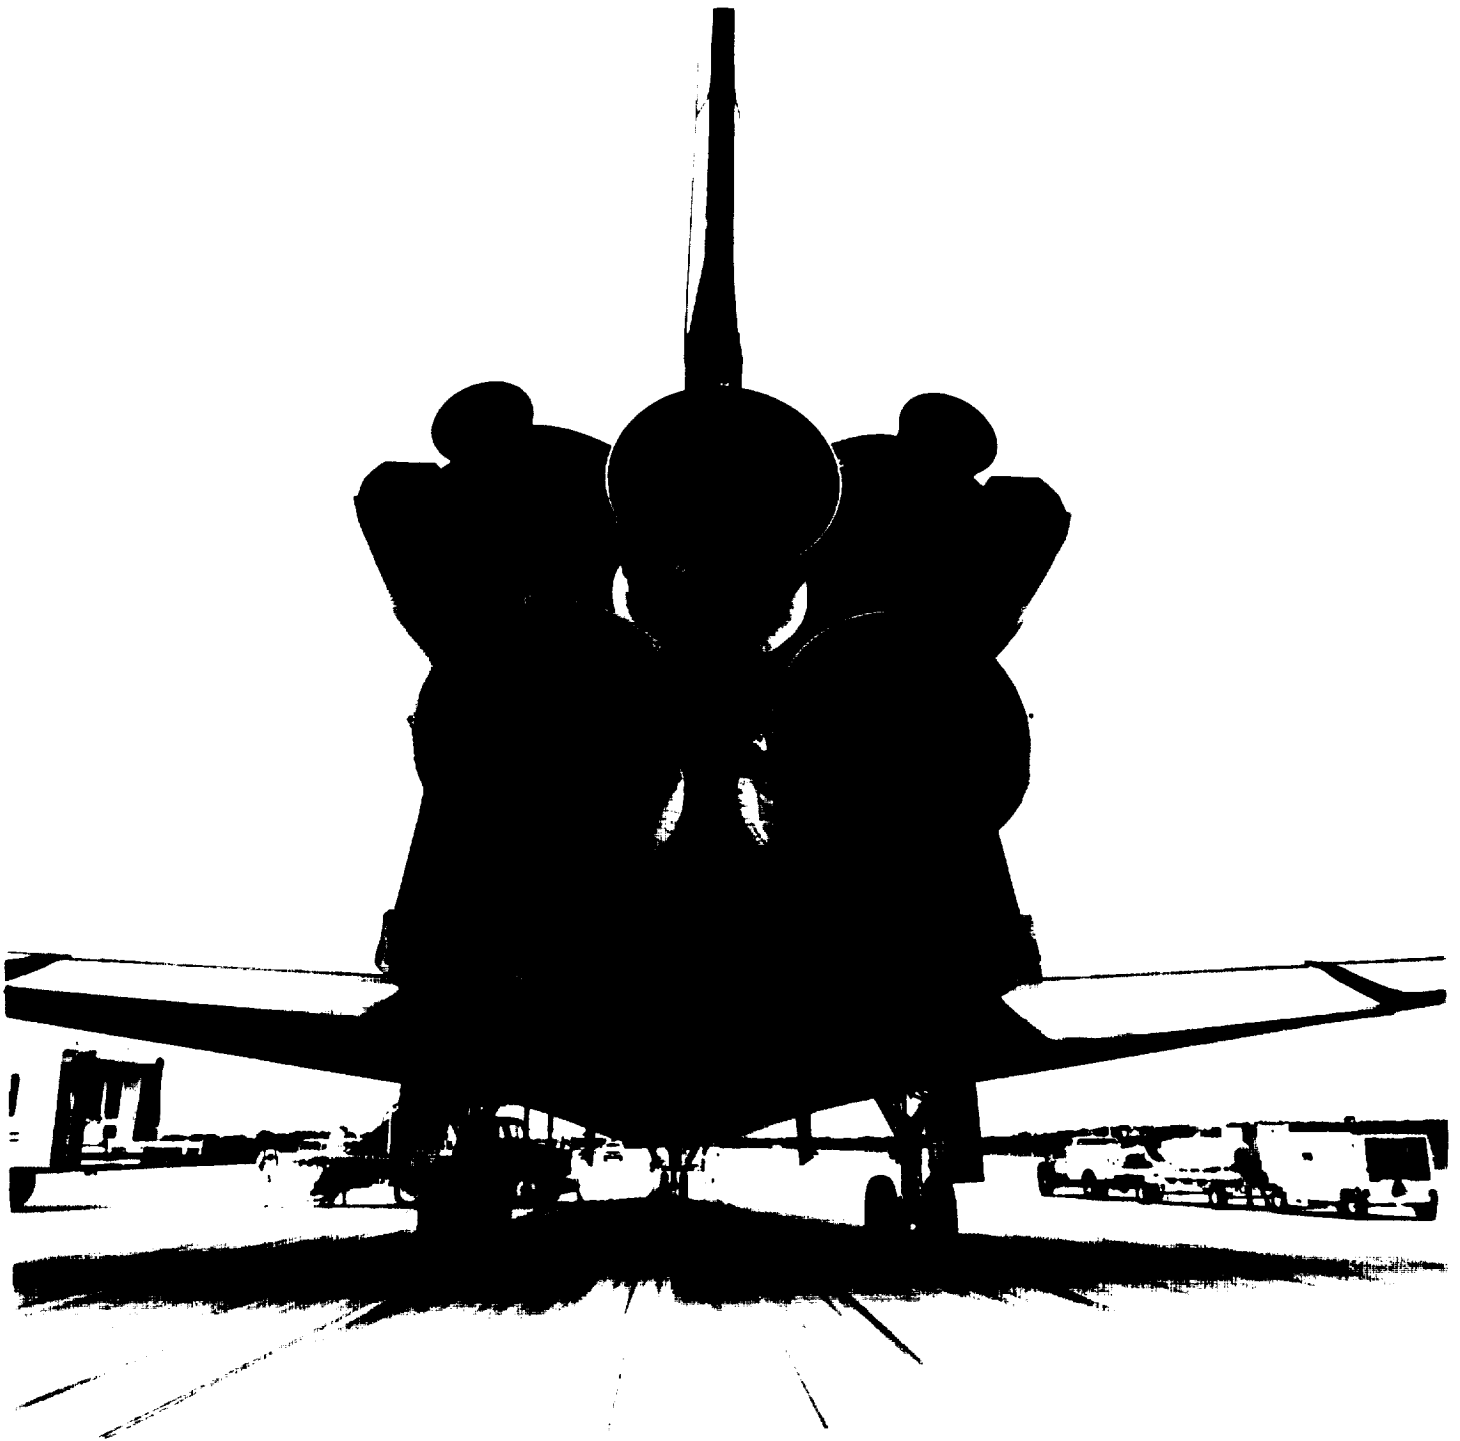
Photo 24: Base Heat Shield/SSME's

The SSME #1 Dome Mounted Heat Shield (DMHS) closeout blankets were torn and frayed at the 7:00 o'clock position. Significant tearing and fraying to the SSME #3 DMHS blankets occurred from 7:00 to 12:00 o'clock. Although the face panels were still attached, some of the underlying batting material may be missing. The SSME #2 DMHS blankets were undamaged.

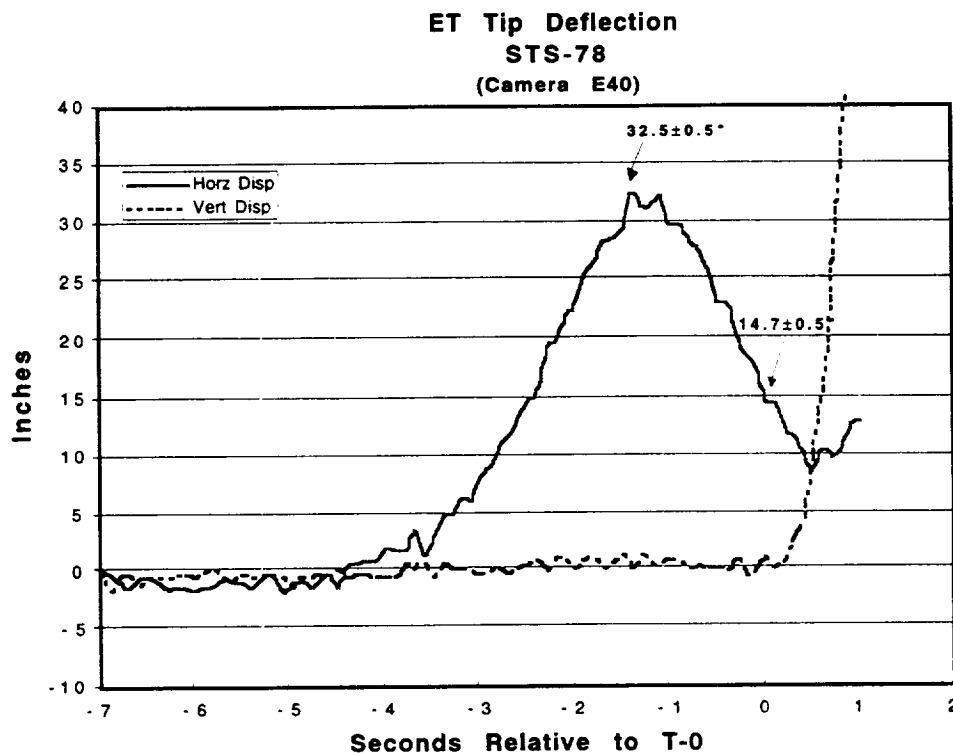
Table 2.2.7 ET Tip Deflection Analysis

To assist in the investigation of the STS-78 SRB heating anomaly, analysis was performed to determine ET tip deflection ("ET twang") during SSME ignition to liftoff. Analysis showed ET tip deflection to be a maximum lateral deflection of $32.5'' \pm 0.5''$ and a tip deflection of $14.7'' \pm 0.5''$ at T-0. The measured maximum and T-0 deflections for STS-78 were within one standard deviation of the deflections seen on previous missions.

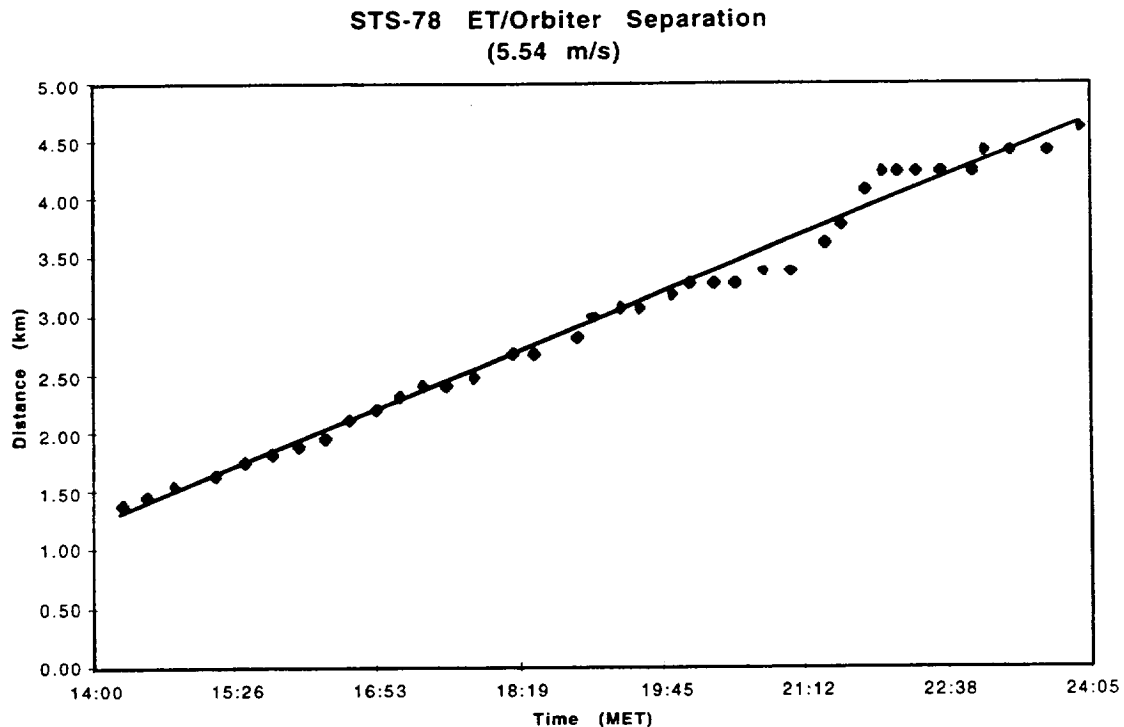
Figure 2.4.2 (B) ET Separation Velocity

The distance of the external tank was calculated over a thirty-eight frame sequence using the hand held photography. The external tank was calculated to be a distance of 1.4 km away from the Orbiter at 14:17 MET. The tank was calculated 582 seconds later (23:59 MET) to be at a distance of 4.6 km. The tank separation velocity was determined to be 5.5 m/s. The separation velocity was similar to previous mission measurements. The tank tumble rate was determined to be 0.7 deg/sec and roll rate was determined to be 0.5 deg/sec.

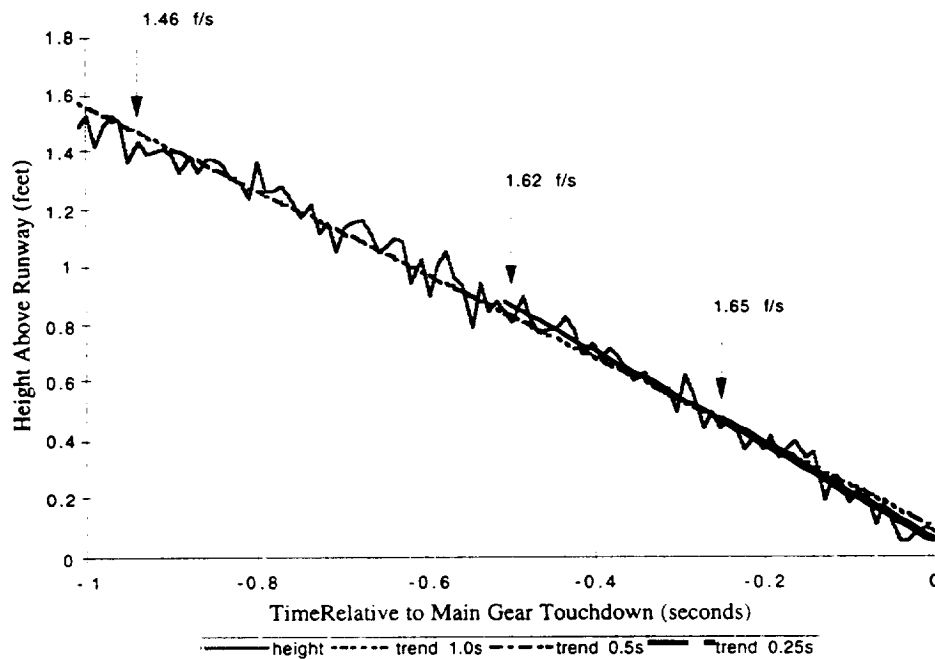
Figure 2.5.1(A) Main Gear Height Versus Time Prior to Touchdown (Film)

The measured main gear sink rate values were found to be below the maximum allowable values of 9.6 ft/sec for a 229,200 lb. vehicle and 6.0 ft/sec for a 240,000 lb. vehicle (the landing weight of the STS-78 Orbiter was reported to be 221,910 lb.). The sink rate measurements for STS-78 are given in Table 2.5.1. In Figure 2.5.1(A), and 2.5.1(B), the trend of the measured data points for film image data is illustrated.
